SOVEREIGN HYDROSEAL PTY LTD

19 November 2010

XNA Sinclair
Xstrata Nickel Australia
Level 3, 24 Outram Street, West Perth
WA 6005
Report : Curtain Grouting between open cut and the Ore body drive.

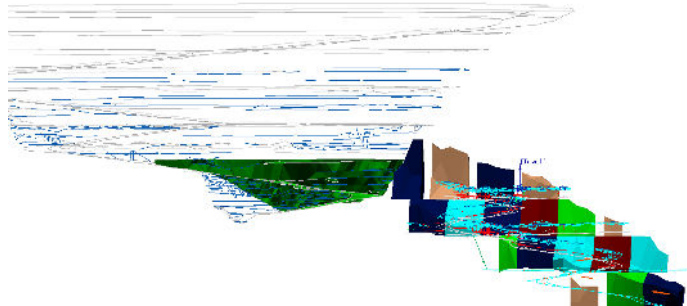
Diagram A

Proximity of the designed underground workings to the open cut created a concern. If the ore is removed as shown in "diagram A" without precautionary measures taken to eliminate or reduce the water intake, it could interfere with or make the underground development impossible/unsafe if a flood occurs.

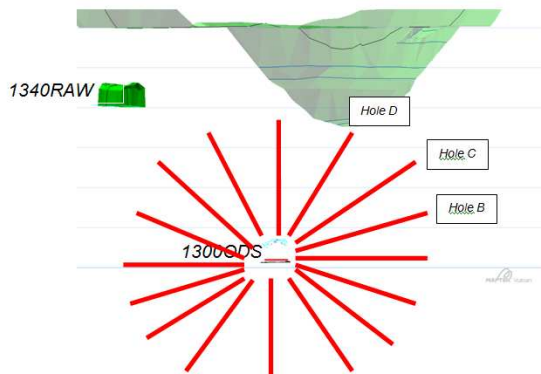
Long hole drilling instruction AN002, Dated 7th October 2010 was designed by Mr. Chad Moloney, Alternate Underground Manager as per our request. Diagram B & C indicates the two rings to be drilled.

With the character of the NOH₂O emulsion grout and the compatibility with conventional cement grout, 3 rings were drilled between the existing open cut and the proposed underground development from the 1300 Level, see Diagram B & C. This allowed access into the formation and enabled grouting to isolate the proposed underground development, connected via water bearing fissures. Ring A was used for cement grouting. Ring B was used for NOH₂O grouting to control the cements "washout" effect, and seal water deeper into the formation in smaller cracks and fissures inaccessible to cementitious grouts. During the grouting phase all drilled holes producing water were pressurised to prevent "loss of hole". Two additional holes R(69°) and Q(56°) were drilled 500mm in front of Ring A, used for NOH₂O grouting after the voids were filled using cement. This placed NOH₂O between the cement and the open cut, further reducing the water intake potential.

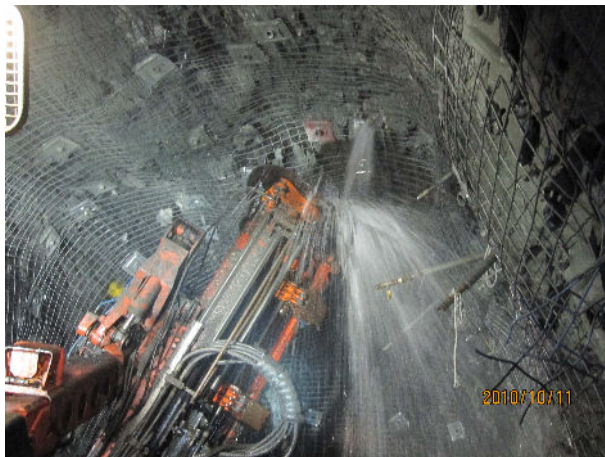
Drilling commenced on the 8th October 2010 in the 1300SOD. Sovereign made an experienced staff member available, to give directions during the process and assist when large volumes of water was intersected. After drill ring B was completed it was evident that most of the water was concentrated between holes A (0°) and Hole E (90°). Hole C (45°) and D (67.5°) intercepted large volumes of water and voids between 3 and 8 meters in drill depth. **Drill holes between 0° and 67.5° could not be drilled to required 30m in length due to the amount of water the holes were producing, on average the holes were drilled to 12m. The volume of water was sufficient to "overflow" the sumps in the main decline, see Photo A & B.** The Solo operator was instructed to stop drilling when significant water was intersected, retract rods and pulled out the drive. Holes were temporarily plugged with grouting packers equipped with valves.

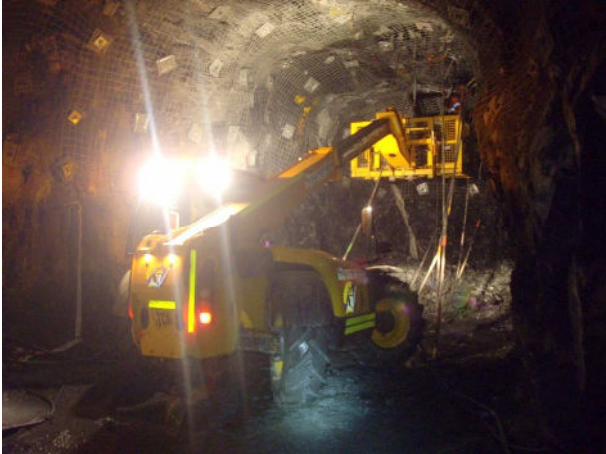
Photo C

Photos C & D showing installation of grouting packers and hose.

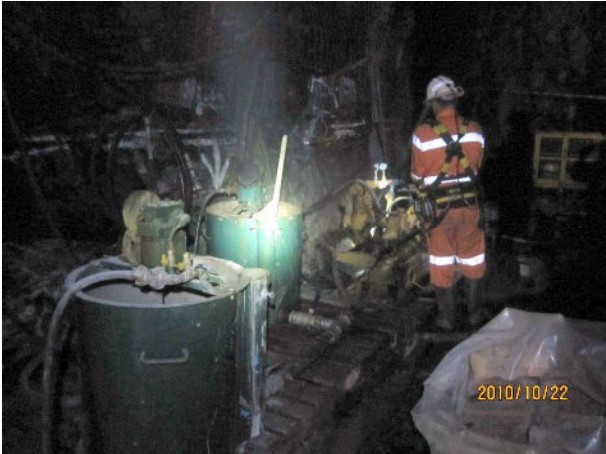
Photo E

Photos E, F and G showing grouting equipment used and final result.

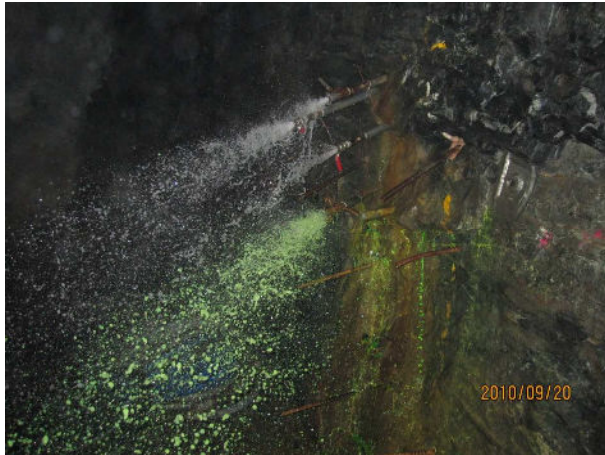
Before

Exploration diamond drilled holes were used to monitor progress during the installation of the grout curtain. See photos below showing water inflow before and after Curtain Grouting Installation, taken in the 1300 SP South.
