SOVEREIGN HYDROSEAL PTY LTD

19 November 2010

XNA Sinclair
Xstrata Nickel Australia
Level 3, 24 Outram Street, West Perth
WA 6005
Report : Curtain Grouting between open cut and the Ore body drive.

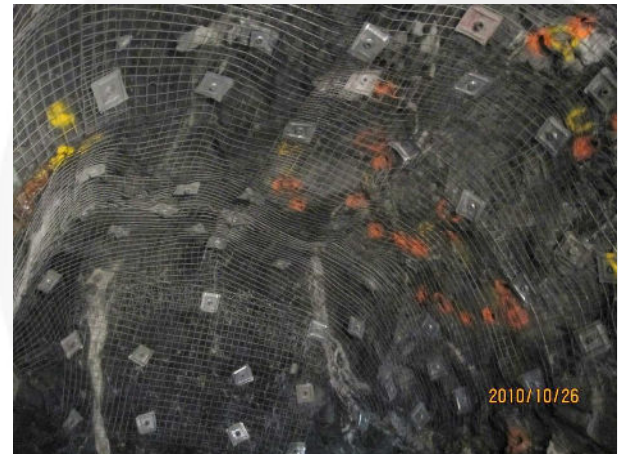
Photo H

Exploration diamond drilled holes were used to monitor progress during the installation of the grout curtain. See photos below showing water inflow before and after Curtain Grouting Installation, taken in the 1300 SP South.
